UNITED STATES  
DEPARTMENT OF LABOR  
MINE SAFETY AND HEALTH ADMINISTRATION

REPORT OF INVESTIGATION

Fatal Slip/Fall of Person Accident  
January 8, 2020

Wendling Quarries Inc.  
Portable Crushing Department 415  
Garrison, Benton County, Iowa  
ID No. 13-02061

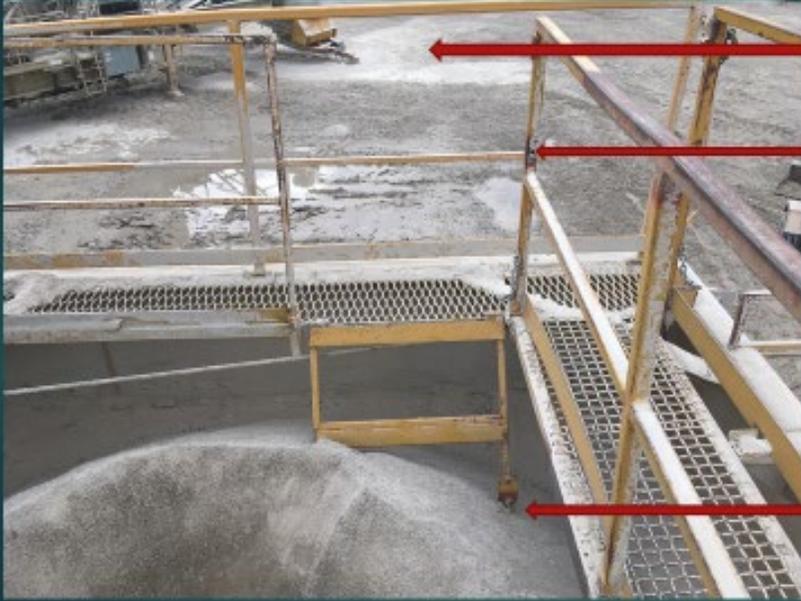
**APPENDIX B**  
South Gate

An accident, resulting in fatal injuries, occurred on this mine site on January 8, 2020, sometime shortly after 1:00 p.m., when a miner fell through an opening in the handrails and fell into the lime surge hopper and was engulfed in material. The stockpile truck driver job duties required him to access the lime surge hopper elevated walkway and clean the interior wall of the lime surge hopper with a scraper. The walkway at the rim of the lime surge hopper was not suitable to prevent miners from inadvertently falling into the lime surge hopper. Or, in the alternative: 56.11002 – Handrails and toeboards. A gate in the handrail of elevated walkway of the lime surge hopper was left open and the miner fell through the opening into the hopper resulting in the death of the miner.

Accident Scene

Opening in handrail where victim fell into lime surge hopper.

Connecting pin not in place at the time of investigation

Locking plate for connecting pin

**Corrective Action:** The mine operator repaired the gate latches on the lime surge hopper walkway to prevent persons from falling into the lime surge hopper.

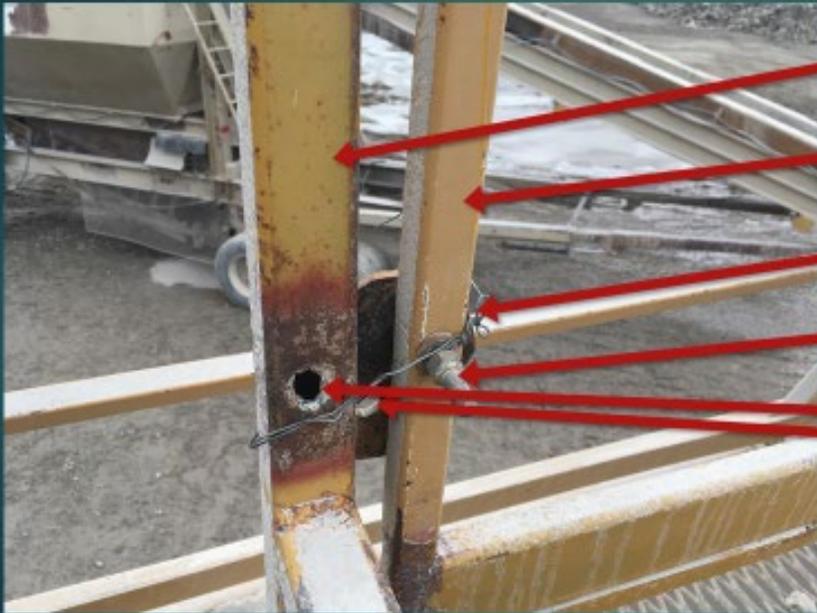
**APPENDIX C**  
North Gate

At the time of the investigation, the access gate on the south side was in the down position and the access gate on the north side was held in place solely with wire (see Appendix C). Investigators searched for and did not find any round lock pins or wire similar to that used to secure the north-side access gate at the accident scene or in the material in the truck or lime hopper.

Condition of north side gate at time of investigation

Wire used to hold gate  
in place

Holes in gate latch and  
newel post used to  
secure gate with round  
lock pin
