# Environmental Alert – Secondary Containment Leak

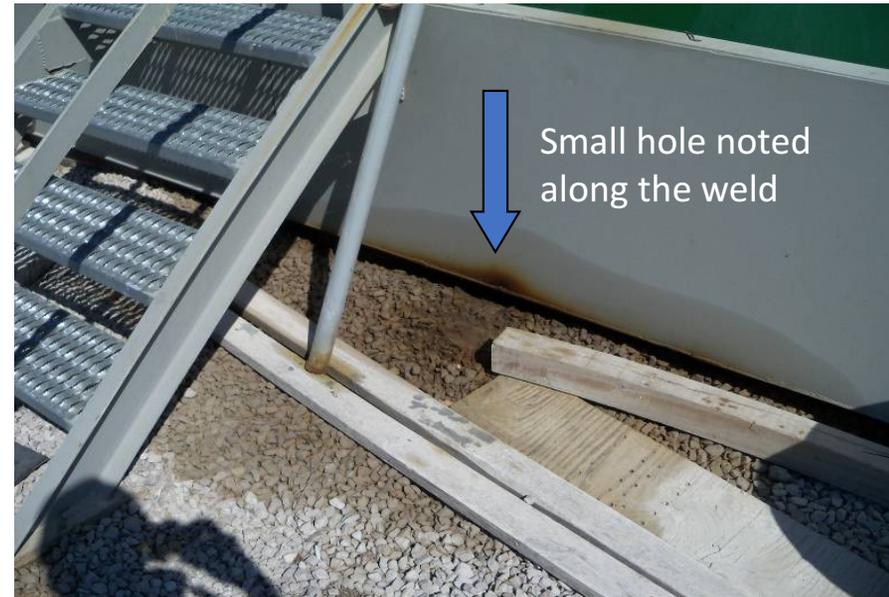
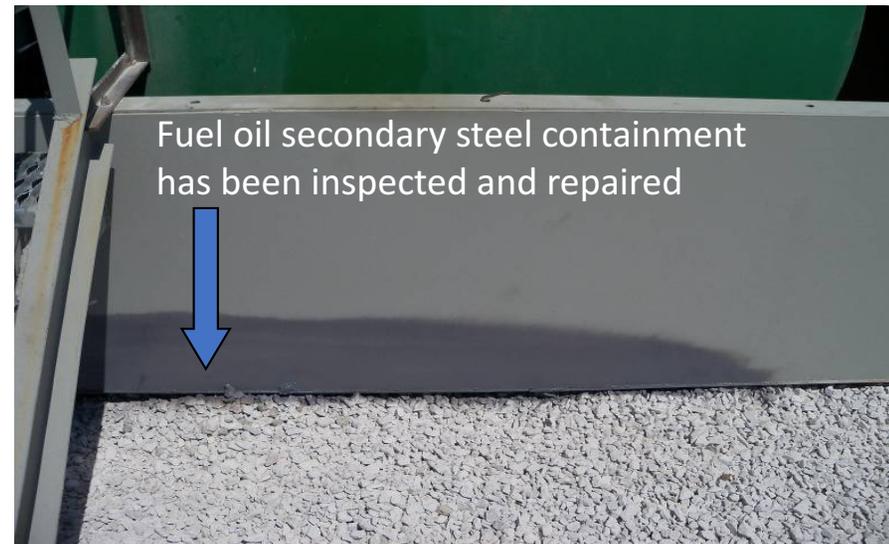
- Secondary containment hole was discovered during Storm Water inspection by the DEQ.
- Staining indicated some fuel escaped the secondary containment.
- After further investigation the oil stain only impacted the surface gravel.
- The hole was fixed and the tank re-painted.
- The contaminated soils were placed on plastic and covered awaiting results to determine disposal options.

- Inspect all secondary containment during routine fueling operations.
- Ensure these areas are included in the monthly NPDES, SWPP plan and SPCC inspections.
- Every quarter conduct a thorough inspection of the secondary containment. Ensure no rust is visible and welds are intact.
