Safety Alert – Thawing Frozen Material

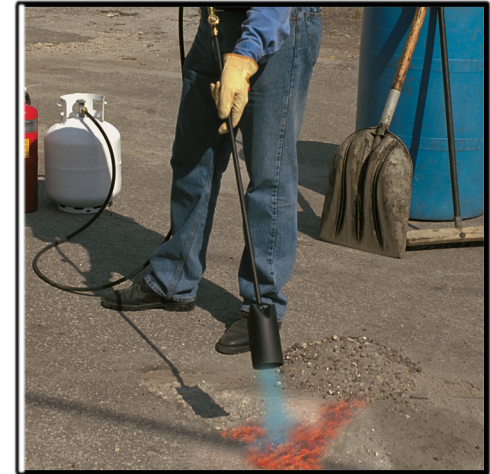
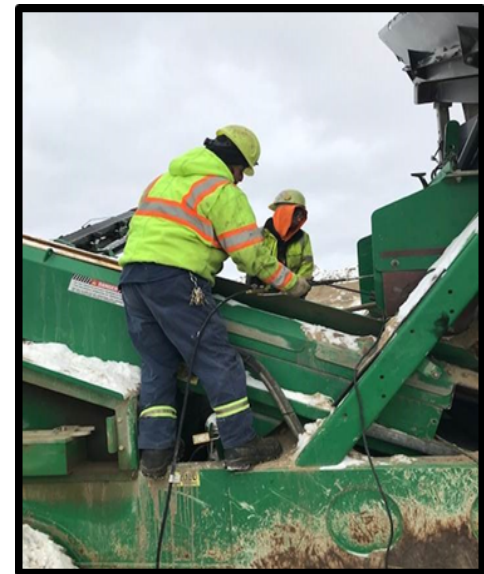
- A bearing on the tail pulley of the screen feed conveyor on the portable plant broke. The repair took longer than expected, resulting in material being left in the hopper overnight.
- The next day the hopper was one-third full of frozen material. To thaw the material two employees stood approximately 2 ft off the ground, on a 4" area of the plant frame. The employees were approximately 4.5 ft from one another, on opposite sides of the hopper, each one using a weed burner.
- One of the employees was wearing ice cleats while standing on the steel frame, resulting in his foot slipping, losing balance and waving his arm, while holding the weed burner, in attempt to regain his balance.
- The waving motion resulted in the employee passing the torch in front of the other employee's face, singeing his mustache and eyebrows and causing a slight burn to his face.

- The tail pulley bearing on the screen feed conveyor failed
- Material was left in the hopper overnight, which froze due to the cold temperatures
- Insecure footing from wearing ice cleats on a metal surface
- Lack of face and fire protection (PPE) while using a weed burner
- Inadequate distance between employees while using a weed burner

- Screen panels in tail pulley guards so you can monitor Tail Pulley
- Safe access for all jobs
- No ice cleats on steel surfaces only snow and Ice
- Make sure to wear proper PPE
- Train miners to stop/pause work when changes in the process occur and determine if any new hazards were created
