UNITED STATES  
DEPARTMENT OF LABOR  
MINE SAFETY AND HEALTH ADMINISTRATION

REPORT OF INVESTIGATION

Fatal Slip/Fall of Person Accident  
January 8, 2020

Wendling Quarries Inc.  
Portable Crushing Department 415  
Garrison, Benton County, Iowa  
ID No. 13-02061

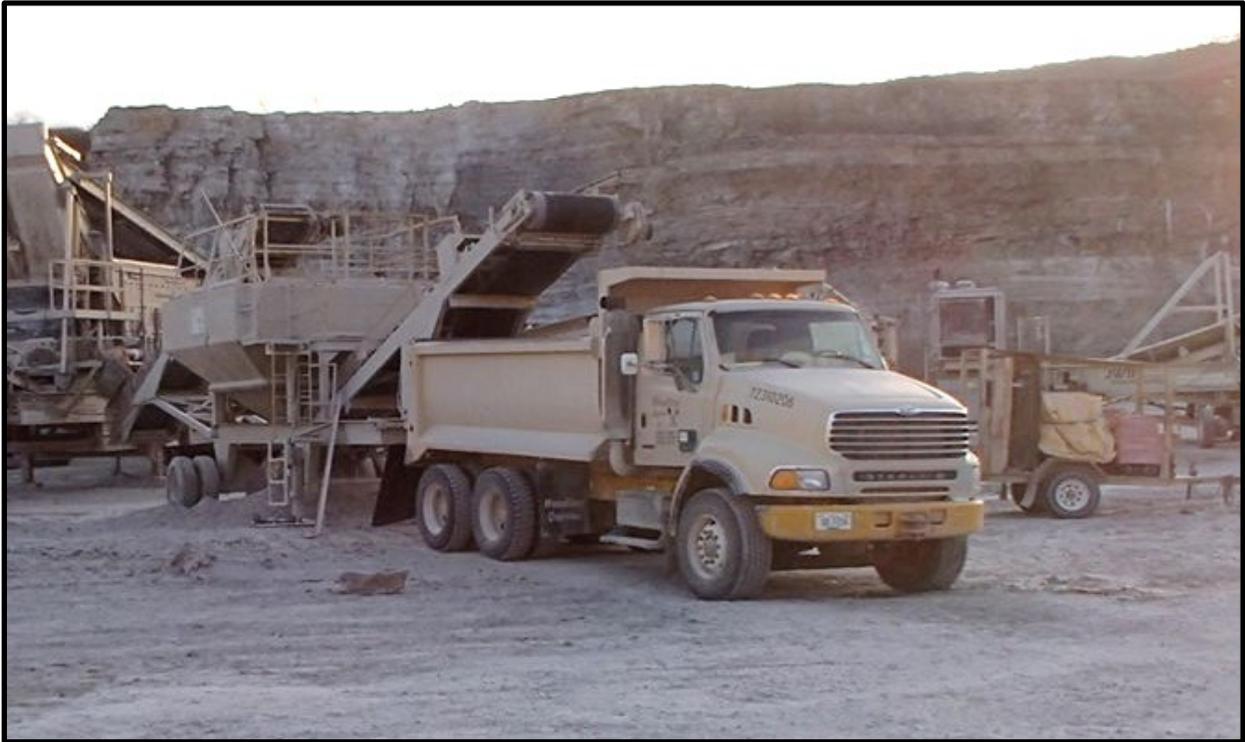
Michael L. Griffith, a 30-year-old Truck Driver/Quality Control Person with one year and eight months of total mining experience, died on January 8, 2020. Griffith died when he fell into a lime surge hopper and became engulfed by the material.
